From Alan McLennan  
Project Manager

## **LTMP Inspection of ex-HMAS Adelaide wreck**

12/7/2018

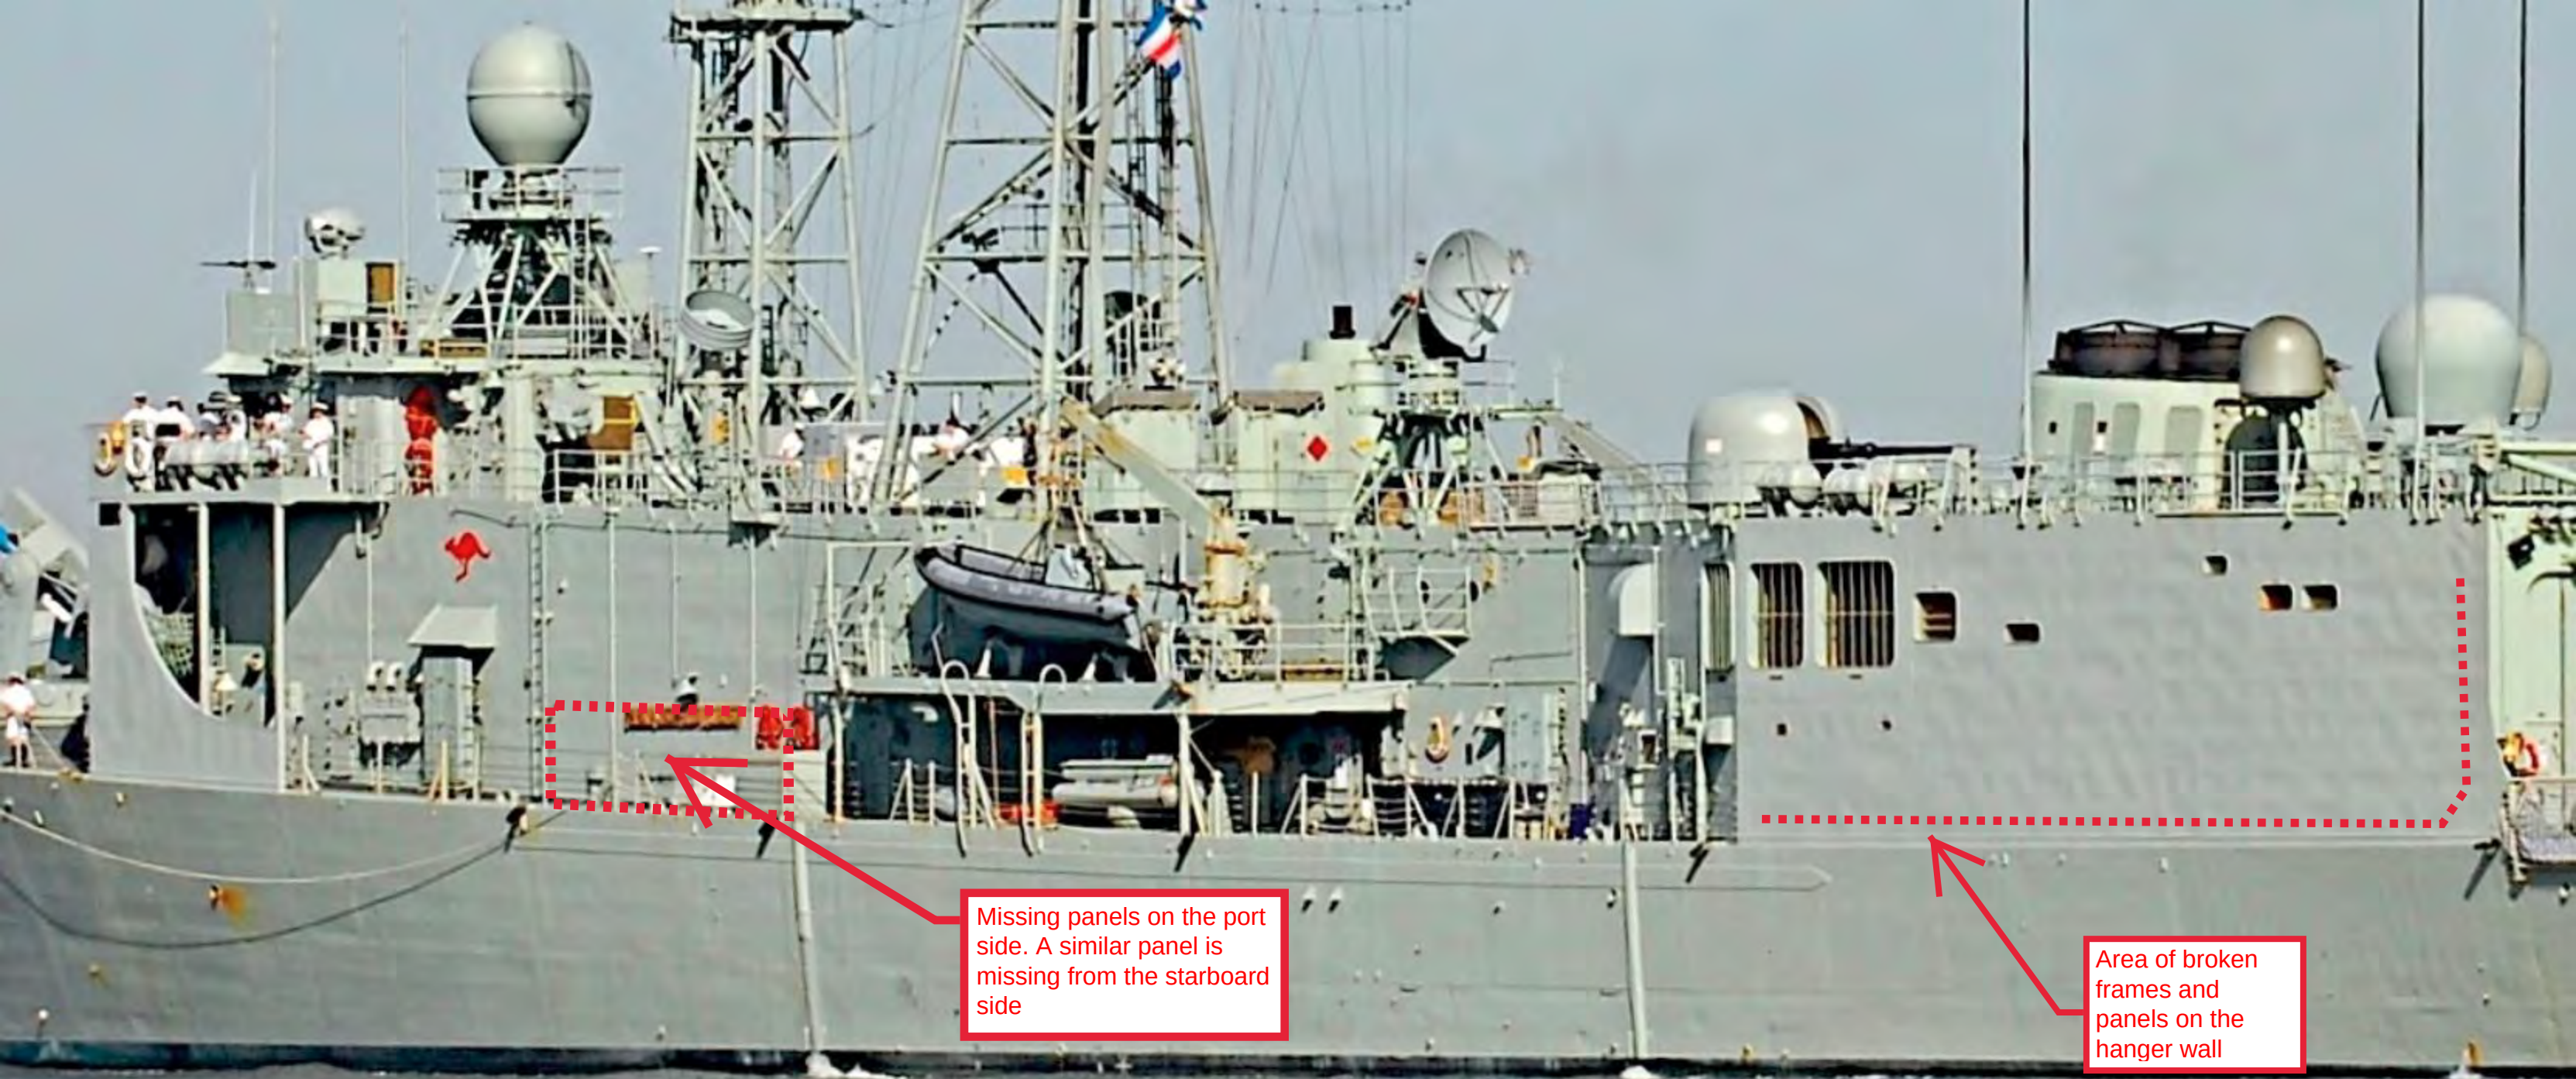
Missing panels on the port side. A similar panel is missing from the starboard side

Area of broken frames and panels on the hangar wall

The missing exterior wall panel on 01 deck, port side. It is approximately 3m long and 2m wide. The opening has allowed swell surge to dislodge fitting inside,

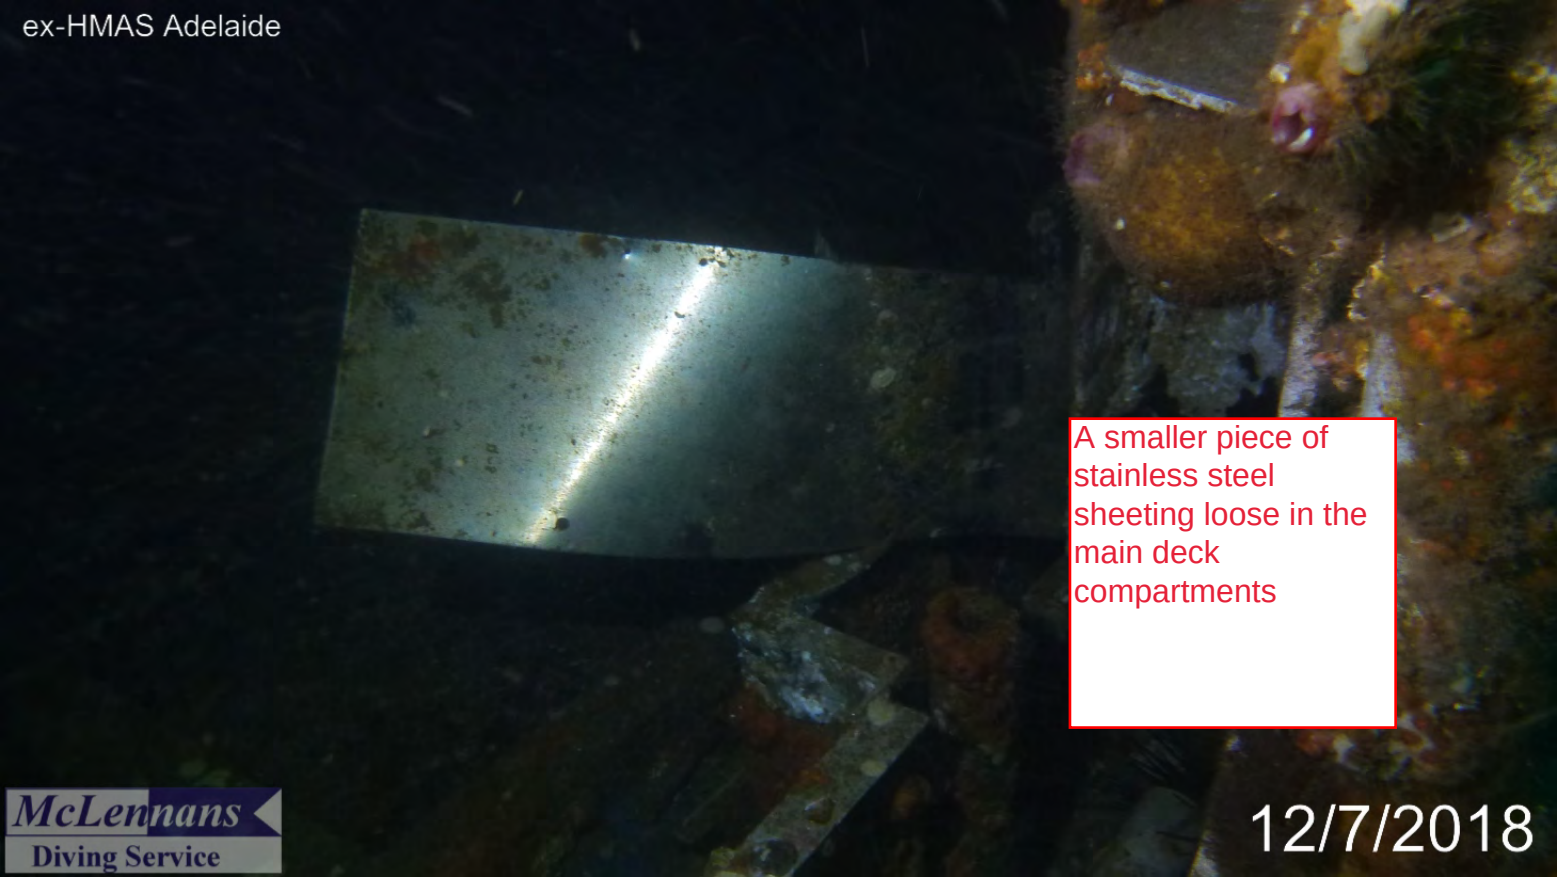
1. The Port Side Helicopter Hangar Wall – The entire hangar wall has cracked on two sides and all of the aluminum sub frame members have sheared from their connections with the main deck. We observed that the wall was moving backwards and forwards over 150mm in the gentle swell. The failure of this wall is mirroring the failure of the starboard wall which broke away during a storm event in May 2015. I expect that this wall will also break away soon, probably during the next East Coast Low.

A smaller piece of  
stainless steel  
sheeting loose in the  
main deck  
compartments

This is the lower aft corner of the portside hangar wall, viewed from the inside. The panel was swaying backwards and forwards 150mm when we visited.

This is the portside hangar wall showing the break at the first frame member. Refer to next picture to see the degree of movement

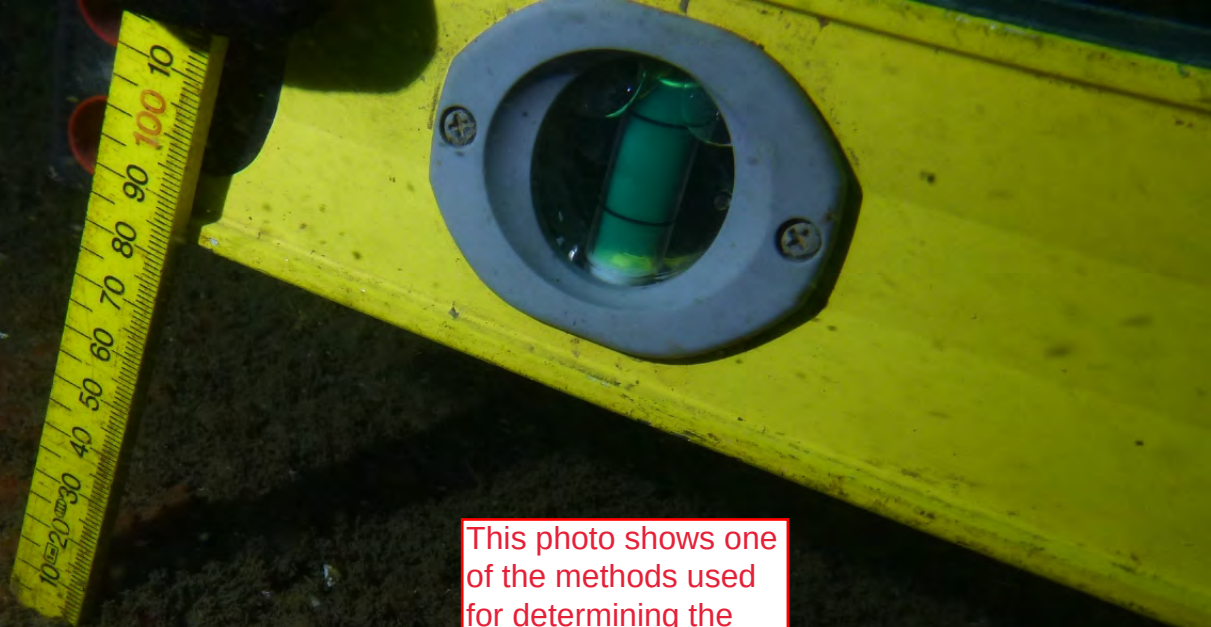
2.1.3 Vessel Stability – The vessel's list was checked by measuring the water depth on opposite gunwales amidships. And by measuring with spirit level. We found that there is an 800mm difference between the two sides of the vessel which is equivalent to a 4 degree list to port. This is unchanged from previous years.

This photo shows one of the methods used for determining the list.

The list is unchanged since last year.

Approximately 4 degrees to port.
