# **Ex-HMAS Adelaide Artificial Reef Reef Community Monitoring Survey 4**

**Job Number: EL1112024F**

**Prepared for: Department of Primary Industries – Catchments  
and Lands**

**August 2012**

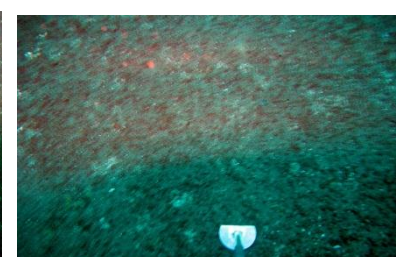
**Plate 3:** Deck Port Stern

| Position | Description of Assemblage |
|---|---|
| Deck Port Stern | The deck was predominantly covered in serpulid worm tubes, covered with small barnacles, encrusting algae, hydroids and fine filamentous algae. Some sand and occasional patches of orange encrusting sponge and red encrusting algae was also observed. |

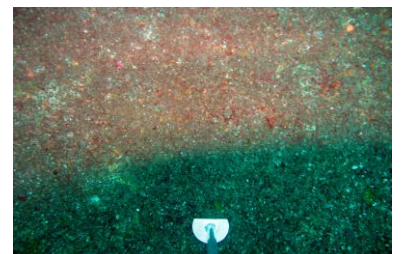
**Plate 4:** Deck Starbord Bow

| Position | Description of Assemblage |
|---|---|
| Deck Starboard Bow | Encrusting growth of predominantly serpulid worm tubes, small barnacles, encrusting algae, hydroids and fine filamentous algae was abundant on the flat areas of the deck with patches of encrusting sponges. Tarwhine ( <i>Rhabdosargus sarba</i> ) were abundant in schools and observed feeding on the deck. |

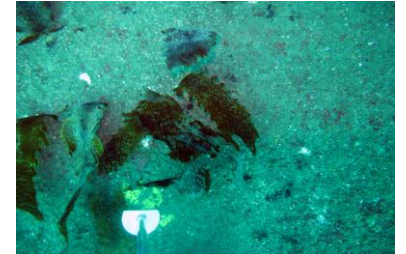
**Plate 5:** Deck Starbord Mid

| Position | Description of Assemblage |
|---|---|
| Deck Starboard Mid | Kelp ( <i>Ecklonia radiata</i> ) fronds have grown notably following the previous survey particularly along the edges of the midships (although this was not evident from the photoquadrats). An unknown bright white encrusting substance (observed in previous survey) remained present. The majority of the deck is otherwise heavily encrusted with serpulid worm tubes, small barnacles, encrusting algae, hydroids and fine filamentous algae. The superstructure and areas of railing had become heavily colonised with ascidians and the occasional branching and papillate white bryozoans and sponges. Tarwhine ( <i>Rhabdosargus sarba</i> ) were again abundant in schools and observed feeding on the deck. |

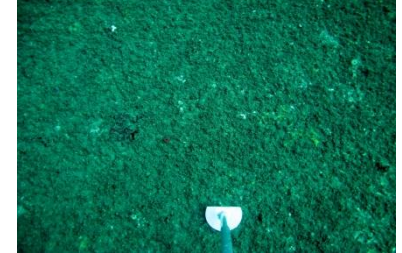
**Plate 6:** Deck Starbord Stern

| Deck Starboard Stern | Encrusting growth of predominantly serpulid worm tubes, small barnacles, encrusting algae, hydroids and fine filamentous algae covered the flat areas of the deck. Schools of tarwhine ( <i>Rhabdoglossus sarba</i> ) were observed. |
